Manhole Inspection Summary

Manhole # S33A__010MH

Insp Date: **8/18/09 10:31 AM**

Location Address: **100 W CENTER ST**

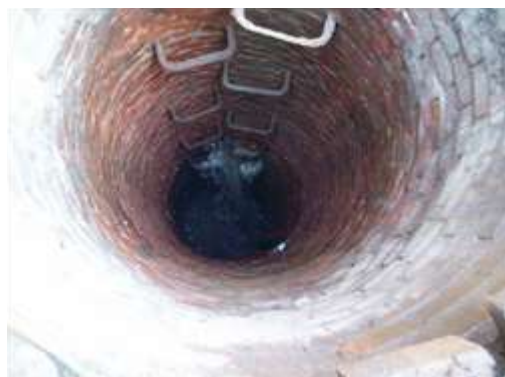
Comments **SURVEY ABANDONED. UNABLE TO PLUG 9 OCLOCK INCOMING**

PLUG NEEDED

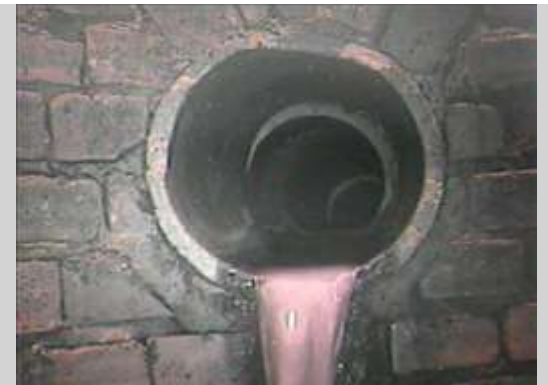
Pipe In @ 3 O'Clock

Invert Depth: **11.13** (ft.) Flow Characteristics: **Slow**

Infiltration: **Weeper** Pipe Seal Cond: **Sound**

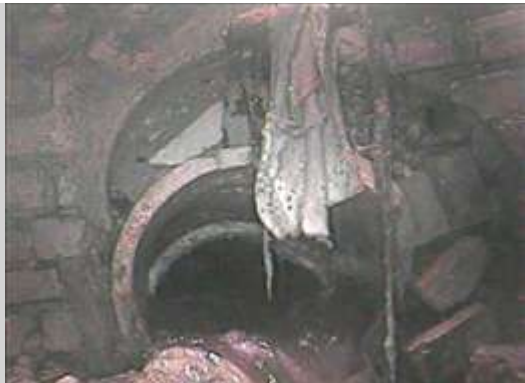
Pipe In @ 9 O'Clock

Deposits: ☐ None ☐ Mud ☒ Sludge ☒ Debris ☒ Grease

Silt Depth: **6** (in.) Deposits Extent: **Medium**

Infiltration: **None** Pipe Seal Cond: **Broken**
